# **Workplace Health and Safety Fatality Report**

**WORKER FATALLY INJURED  
WHEN PINNED BY TANK TRUCK PUP  
Date of Incident: March 11, 2007  
Type of Incident: Fatality**

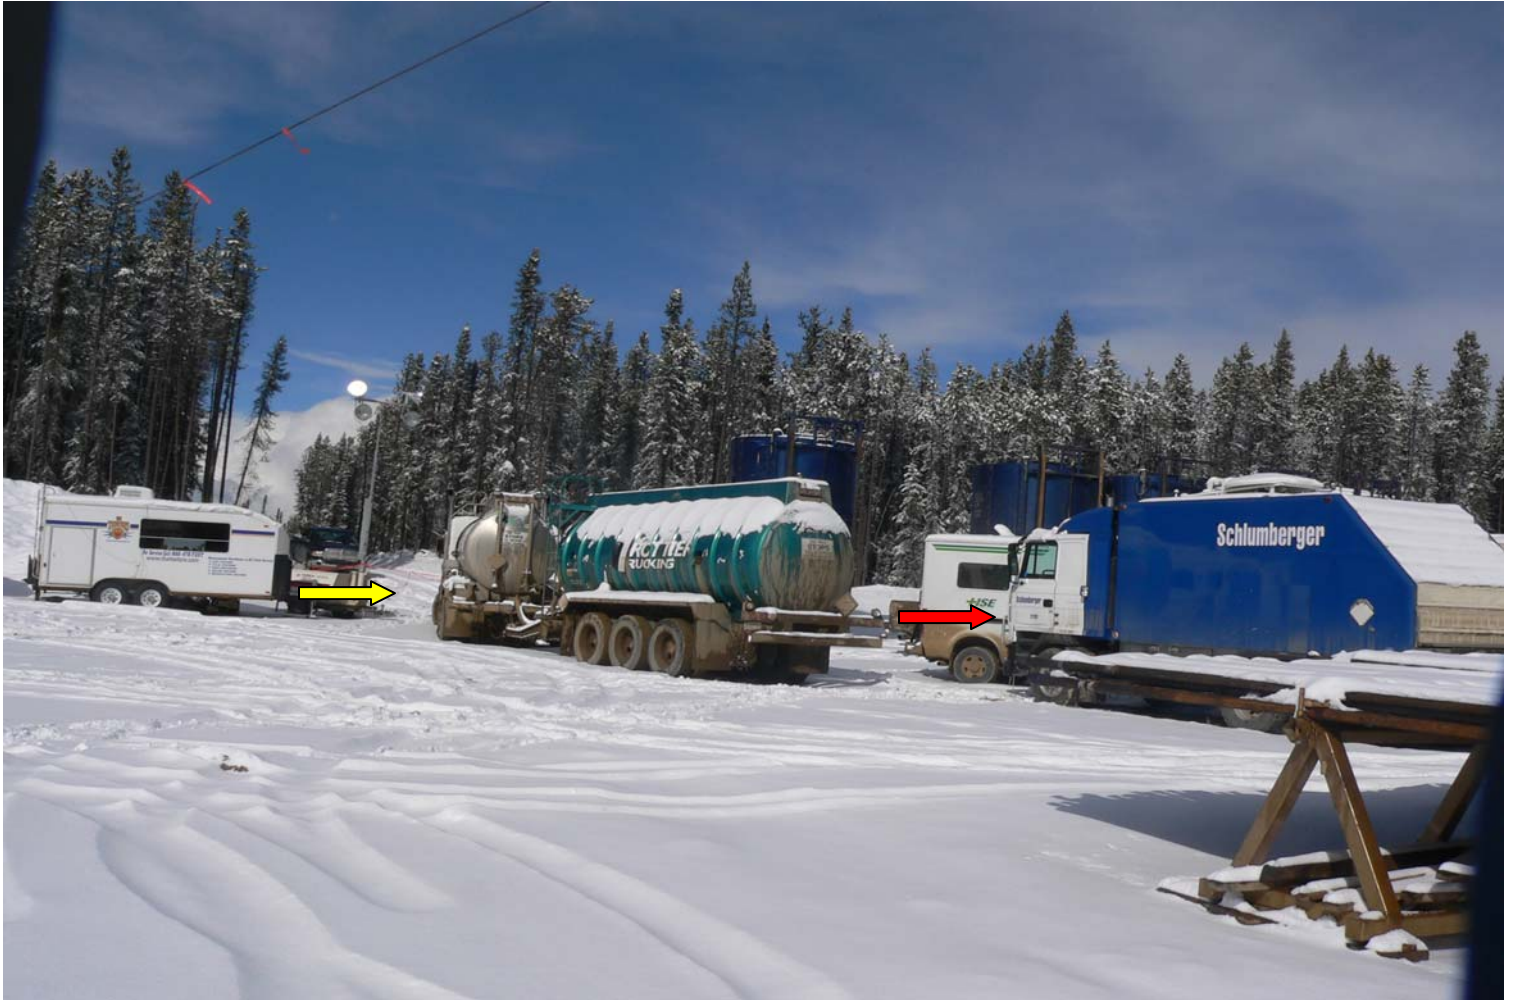
Photograph #1

The wireline truck was backed up to the catwalk of the Concord Service Rig # 24. The wireline truck was utilized for perforating the wellbore. (Attachment A, Photograph 1).

The yellow arrow shows the tank truck and tridem stiff pole pup trailer and also shows the final position of the tank truck after the tank truck driver struck the medic and pulled forward. The red arrow shows the wireline truck where the medic was pinned by the right hand side of the back pup trailer's bumper.

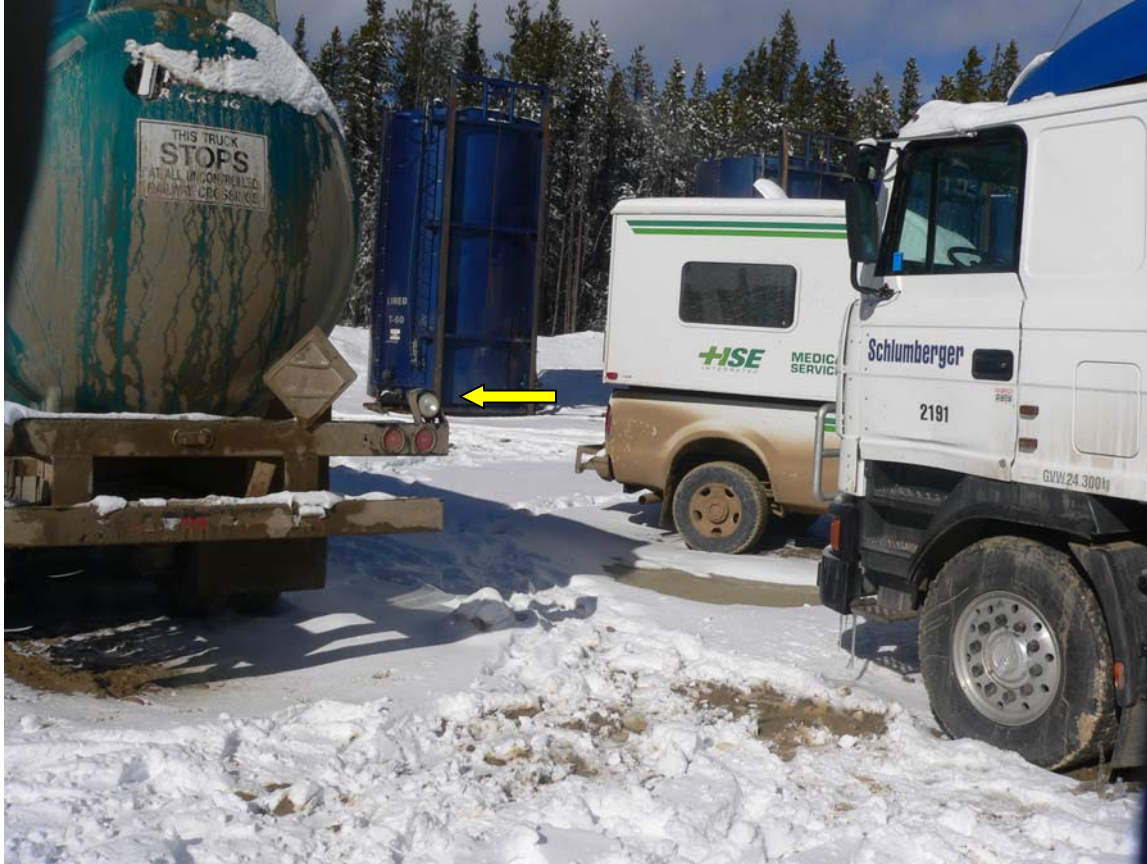
Photograph #2

- 6.9 When the Tank Truck Driver looked back in his driver side mirror he could not see Medic #1. The Tank Truck Driver continued backing up while Medic #1 walked between the pup trailer and a stationary Schlumberger Canada Ltd. wireline truck. Medic #1 was pinned between the back corner bumper of the pup trailer and the driver's door of the stationary wireline truck. (Attachment A, Photograph 2)

Shows where the medic was pinned between the pup trailer and stationary wireline truck. The yellow arrow shows the bent exterior flood light and steel frame on the rear bumper of the pup trailer. The blue arrow shows the damage to the driver's door of the wireline truck. The red star shows the approximate location where the wireline operator found the medic lying on the ground.

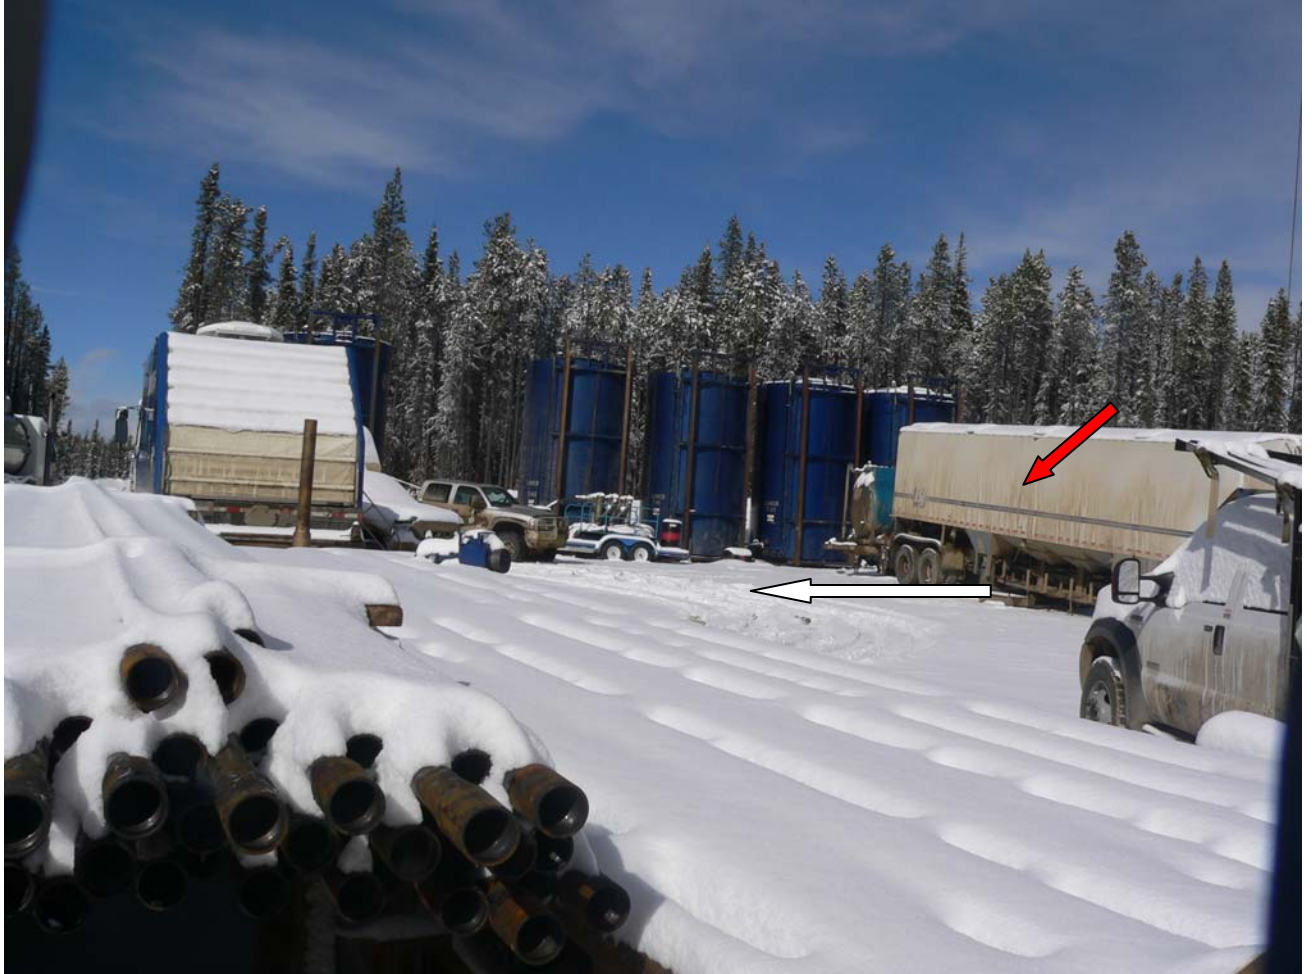
Photograph #3

- 6.13.3 The Workplace Health and Safety Compliance Investigators observed a sand hog trailer on the worksite. The trailer, which was on the worksite for an upcoming fracturing job, was parked in an area that blocked the ability of the Tank Truck Driver to drive forward around the worksite and drive straight out the lease entrance. (Attachment A, Photograph 3) On past occasions when the sand hog trailer was not parked in this area truck drivers were able to drive forward, around the wellsite location, and proceed straight out the lease entrance.

Shows the area where the tank truck was backing out. The white arrow shows the direction the tank truck was backing out from after unloading the 25 m<sup>3</sup> KCl water . The red arrow shows the sand hog trailer that was blocking the path that drivers usually took to drive straight out of the location.
